Cannon Group
Roof, Building Envelope
& Structural Consultants

April 8, 2014 - DRAFT

Re: Visual Inspection & Assessment Report
Vineland Elks Lodge Renovation (Reliance No. 2 Firehouse)
6th Street, Vineland, New Jersey
HJCG No. 20130.057

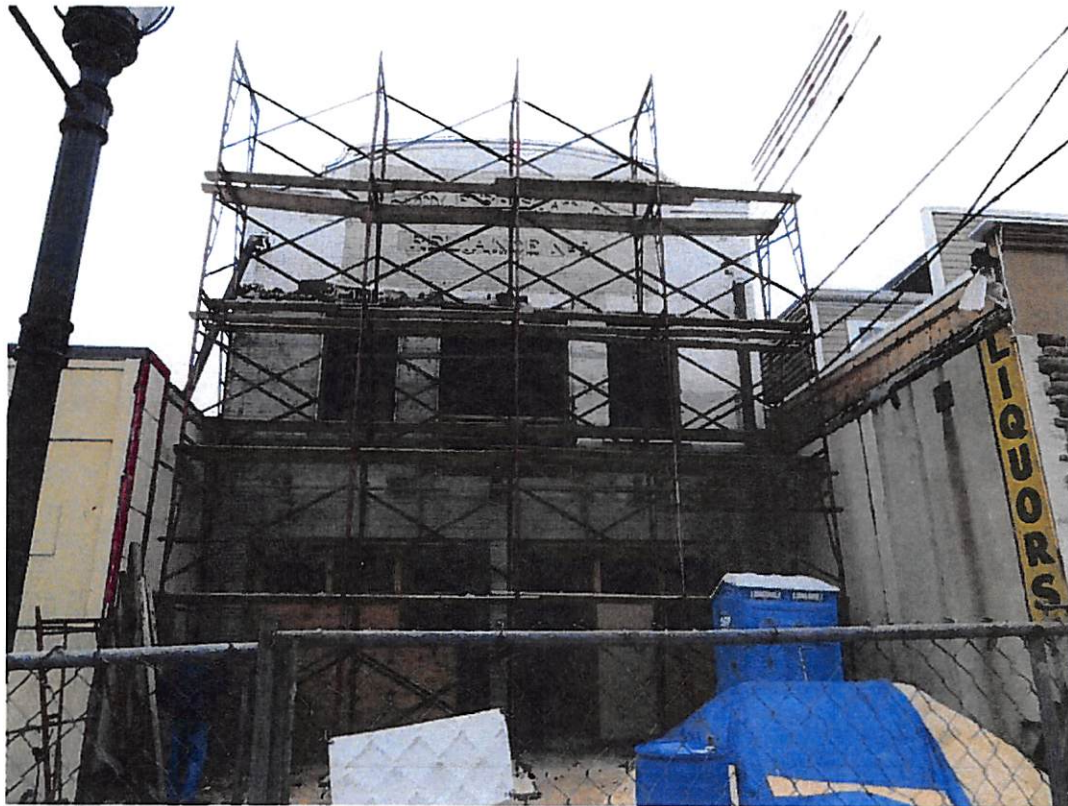
1. The existing building is a two story structure constructed circa 1919 as a firehouse. The construction consists of multi-wythe clay brick masonry walls supporting wood framing for the floor and roof. The east elevation (facing 6th Street) was the front façade of the building. The east elevation was originally constructed with a glazed clay brick that is white in color. Portions of the east elevation had been painted over in the past.

Photograph 1: East elevation of Elks Lodge

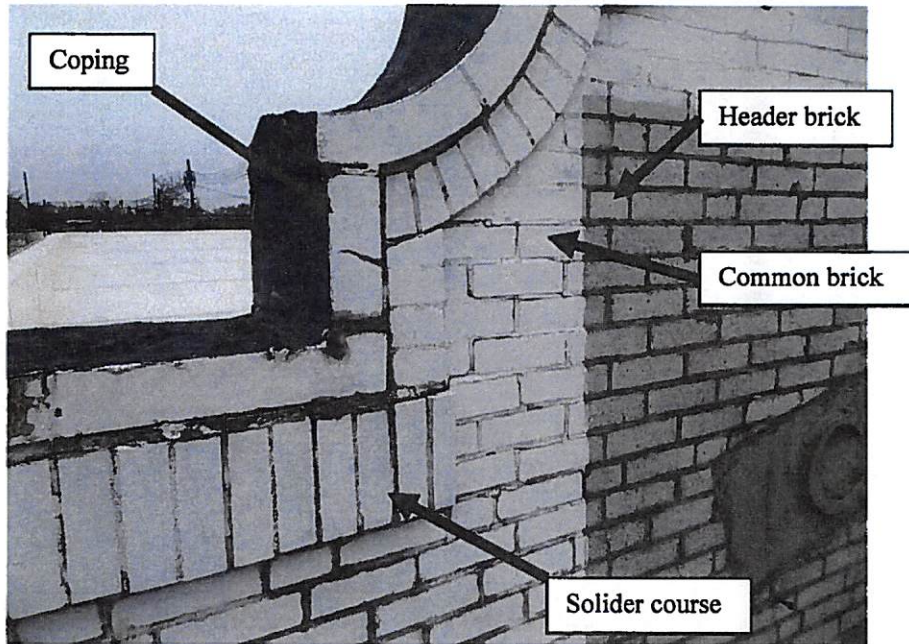
5. The existing copings appear to be cast stone. Roofing tar was applied to the copings in an attempt to limit water infiltration. The brick course immediately below the copings is a "soldier" course. The mortar joints above the soldier course were deteriorated and open yet those between the individual soldier units appeared to be intact. However, the soldier course could be easily dislodged and removed by hand. Probing revealed that the common bond brick below the soldier course was in similar condition and could be easily deconstructed by hand with little effort.

Photograph 2: Wall copings at southeast corner of east elevation

Once the reconstruction is completed, wire latch and the thin brick veneer will be applied to the wall. The original signage will be removed as part of the reconstruction, cleaned, and reset into the reconstructed wall. The original wall copings will be removed, cleaned, and replaced along with new through-wall flashings and appropriate joint sealants.

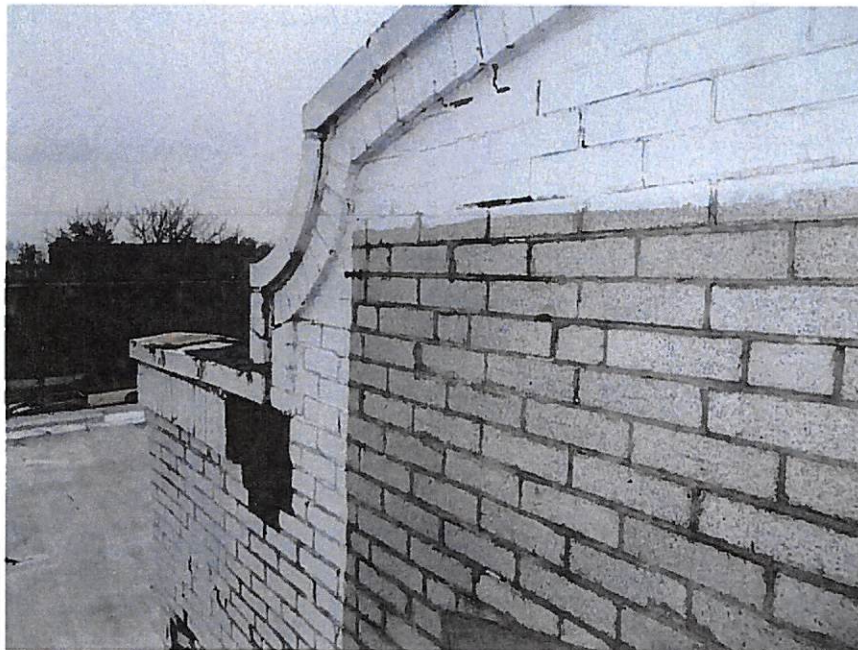
6. Headers are provided between the face wythe of brick and the underlying red brick back-up wythe. Headers are merely bricks that are turned perpendicular to the plane of the wall and are mortared into the face wythe and underlying back-up wythe. The header found in the area of probing at the coping level could be easily removed by hand. There was no bond between the header and the underlying brick back-up wythe. The headers are the mechanical connection between the wythes of brick and are structural.

Photograph 3: Area of brick probing at coping

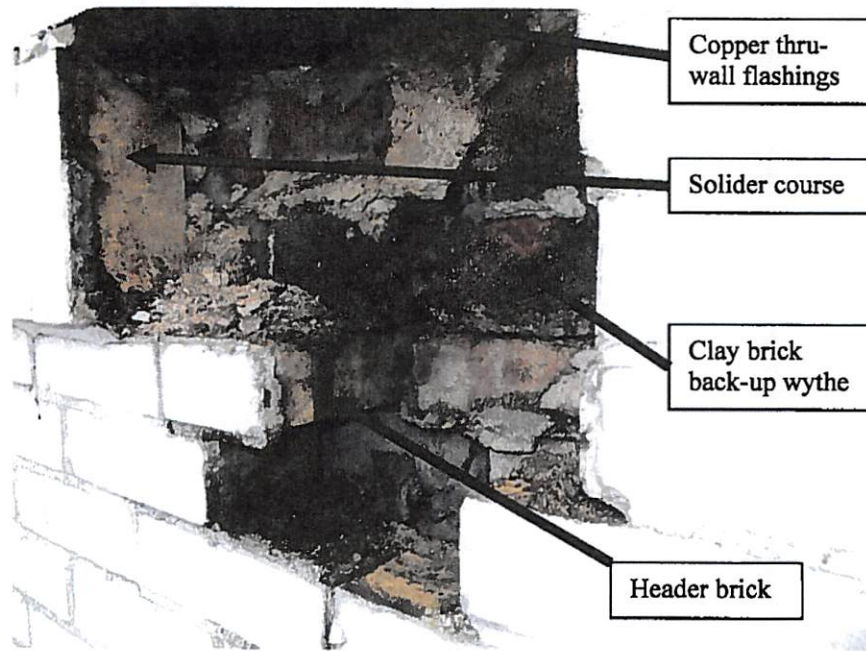
Photograph 4: Area of brick probing at coping

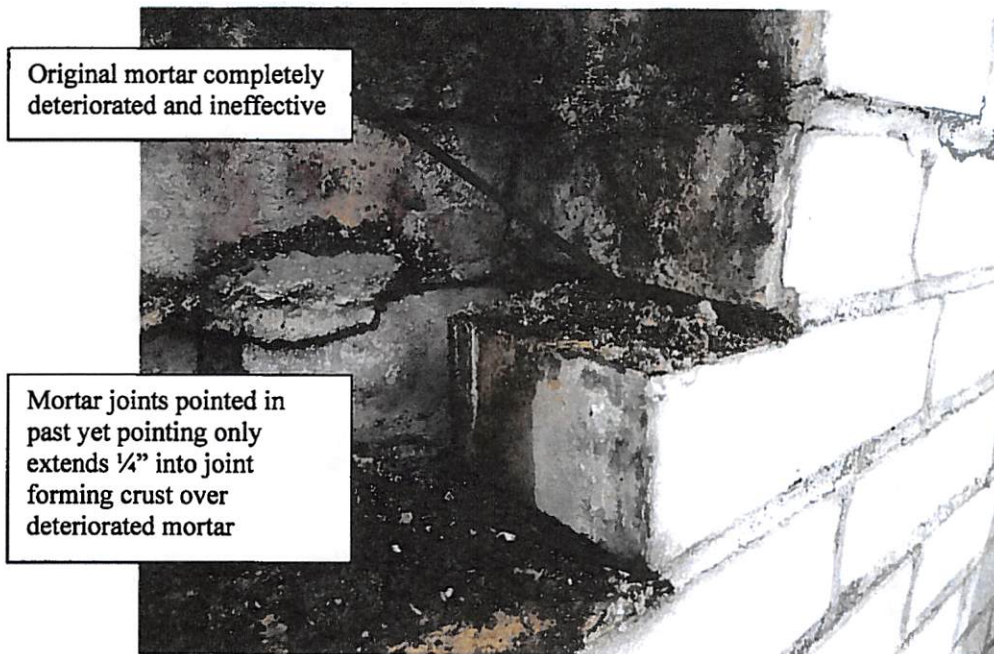
Photograph 5: Exposed conditions at coping probe

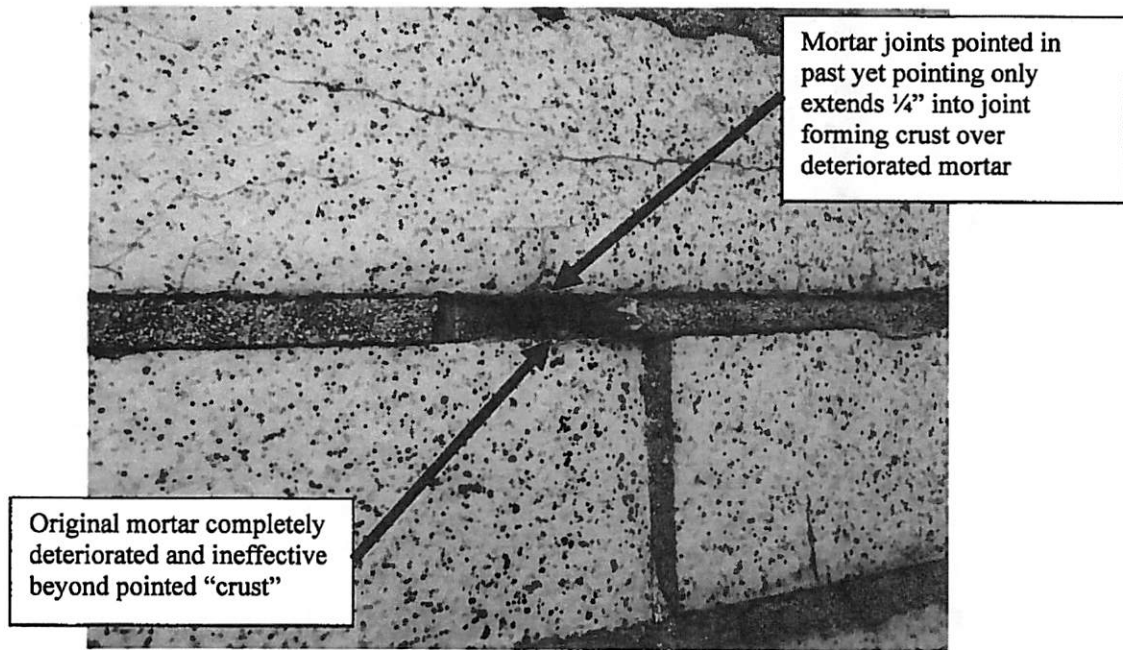
3. The mortar joints were probed by driving a 16d common nail into the joint with a framing hammer. The mortar joints at the first floor and portions of the second level were found to be dense and unyielding. However, once above the height of the second floor windows the condition of the mortar joints changed dramatically. The joints had been repointed at some point in the past. Probing revealed the pointed mortar was similar to a "crust" approximately 1/4" deep. The nail, once it broke through the "crust" could be easily pushed deeper into the mortar joint with only light hand pressure.

4. Sections of the façade were randomly selected and sounded with the framing hammer. A series of moderate blows to the center of the individual bricks were made. The individual brick units could be easily dislodged and "pushed" back into the wall construction as the mortar joints around the entire perimeter of the individual bricks failed.

Photograph 6: Common condition at mortar joints

The existing east elevation of the building was improperly repointed from the second floor elevation to the top of the wall as some point in the past. The original mortar used in the area of the glazed brick may have been either a colored mortar or utilized additional lime in order to lighten the color up to match the glazed brick. The mason who repointed the façade in the past merely scratched out the surface of the joints and installed new mortar overtop unsound materials. The fact that the brick units can be easily dislodged from the wall using a hammer indicated that the mortar joints are deteriorated to the point of failure and provide no bond to the brick units. The bond between the mortar and the individual bricks is needed to maintain stability of the façade to wind and seismic loadings.
